SERVICE INFORMATION DIRECTIVE
Compliance Will Enhance Safety, Maintenance or Economy of Operation

SID 05-1

SUBJECT: THIS SERVICE INFORMATION DIRECTIVE (SID) SUMMARIZES INFORMATION PERTINENT TO THE DESIGN, OPERATION, MAINTENANCE AND WARRANTY FOR TCM CAMSHAFTS AND HYDRAULIC LIFTERS

MODELS AFFECTED: All TCM engine models

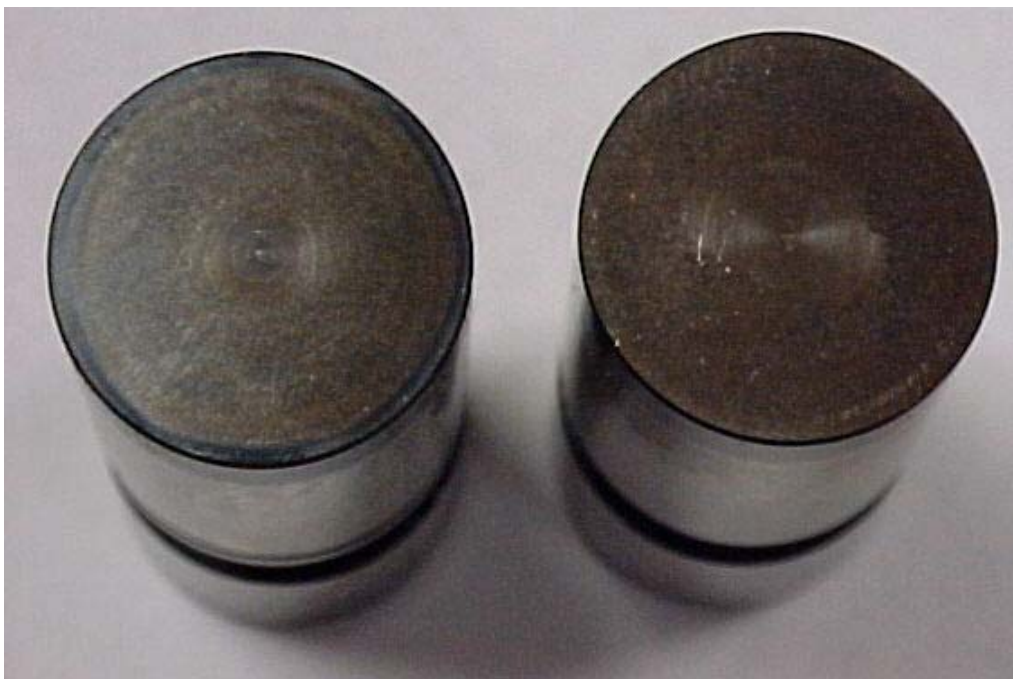
FIGURE 5 TYPICAL LIFTER FACES FROM SERVICE

The interface between a cam lobe and lifter is intended to wear to some degree as the engine operates. This is similar to the piston ring / cylinder wall interface that must seat together for proper operation and wear over time. The manganese phosphate will quickly wear off in loaded areas of the cam lobe and the lifter face. Normal wear may take the form of a bright shiny uniform wear surface, with a circular pattern visible on the lifter face. Damage to the lifters is often referred to as “galling” or “spalling”. Localized areas may show signs of spalling or galling in service due to various operating conditions. Some level of such conditions will frequently be found at overhaul. Note that this wear material as with all other normal wear material will be collected by the oil and trapped in the oil filter element or screen

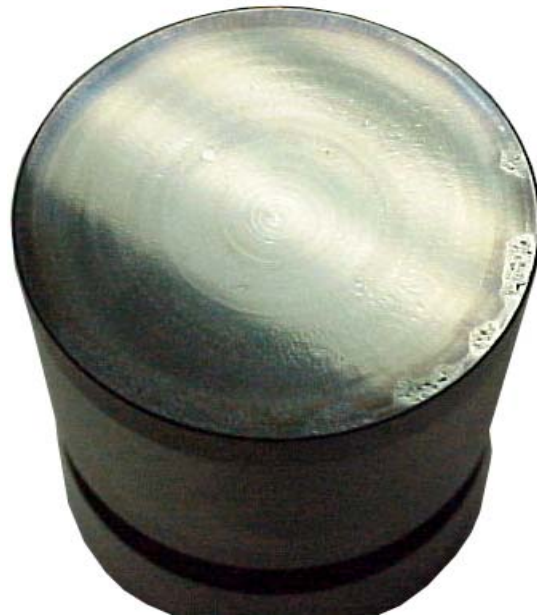
FIGURE 6 MINOR SPALLING

Minor spalling due to corrosion or other factors will not affect operation as the loads are redistributed to the surrounding material. The appearance will be some number of separated spalled areas with polished contact patterns on the remainder of the face. (Reference Figure 6)

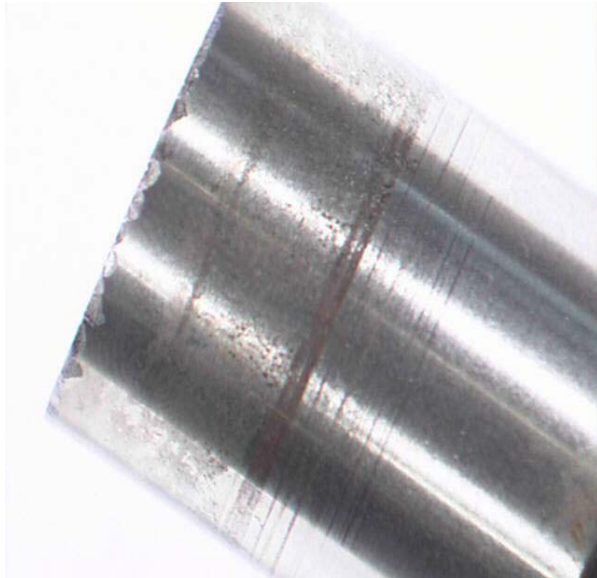
Since the camshaft is steel and the lifter body is iron, rust or corrosion is by far the most common reason for lifters to spall. The pits caused by corrosion are stress concentrations that result in spalling.

CORROSION ETCHING ON BODY

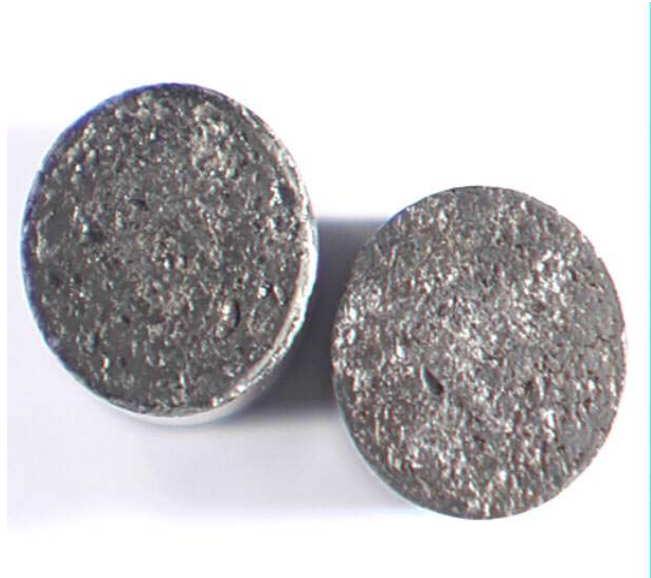
Major spalling that involves much of the face will also usually have no effect on operation and will also frequently “heal over” and re-establish a stable surface for the cam interface. The effect on the cam is minimal. Note that the hydraulic feature of the lifter continuously adjusts for any wear and keeps valve operation normal.

In very rare cases, the lifter deterioration will cause significant wear to the cam lobe. In such cases, the lift of the valve may be reduced. Initially, the effect on performance would be negligible, but may eventually lead to reduction of power of the cylinder effected. Valve lift is in the order of one-half inch so the wear would have to be extreme to noticeably effect cylinder performance. Note that the hydraulic lifter has a limited range of hydraulic adjustment and would run out of travel before extreme wear occurred. This could result in an audible tapping noise from the engine.

FULL FACE SPALLING

FIGURE 7 LIFTER CORROSION AND SIGNIFICANT SPALLING

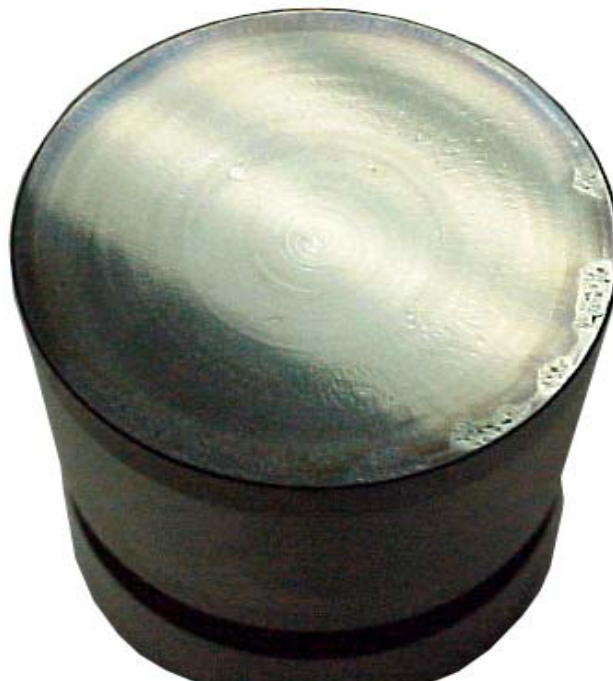
FIGURE 8 ACCEPTABLE LIFTER FACE SIGNATURE

- (7) Remove the hydraulic lifter assemblies from the lifter bores. Mark the lifters for reinstallation into the position from which they were removed.
- (8) If the lifter face and body shows normal signatures, coat with Dow-Corning® G-N paste and reinstall in the same location as removed.
- (9) Reinstall items removed in steps 1 through 6 above (using new tab washers as applicable) using the latest revision of the appropriate maintenance or overhaul manual and the latest revision of Service Bulletin SB96-7 Torque Limits.

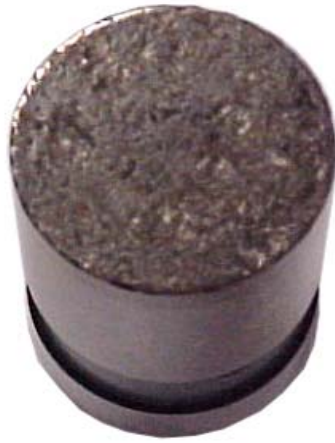
FIGURE 9 REPLACEMENT SIGNATURES, SPALLED LIFTER

Replace lifters with severe face or lifter body wear signatures or spalling that exceeds 10% of the surface area. Lifters associated with noise indicating excessive valve lash should also be replaced regardless of face condition.

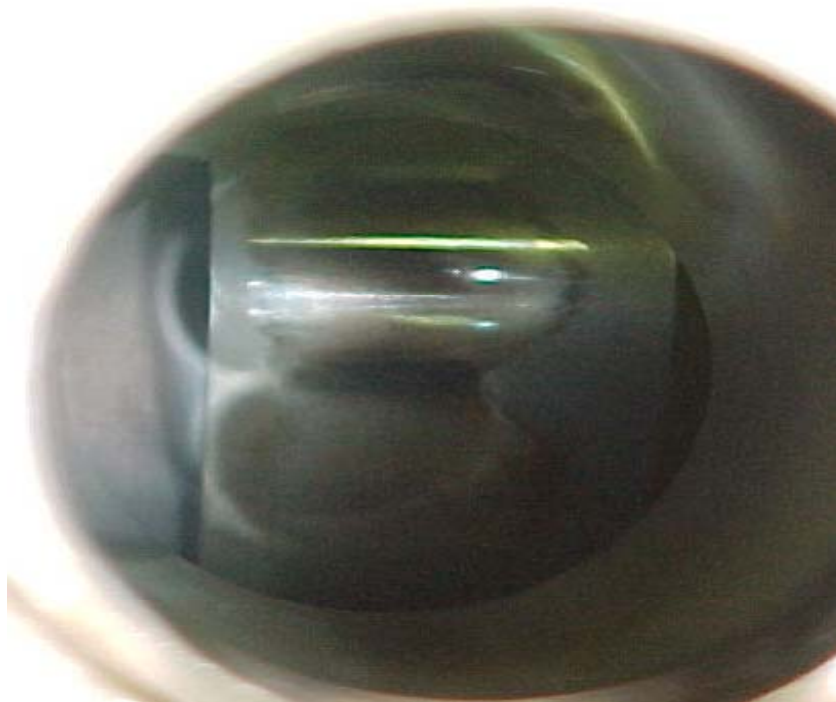
FIGURE 10 CAM LOBE APEX IN INSPECTION LOCATION
(Normal wear signature shown)

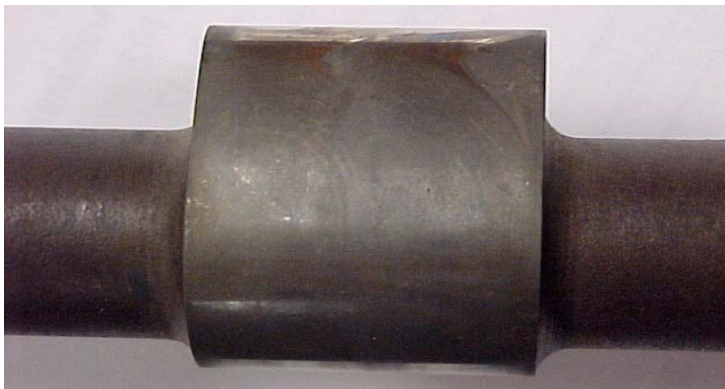
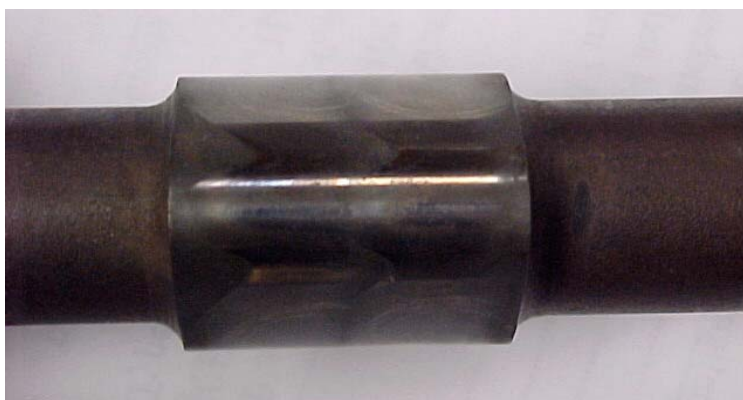
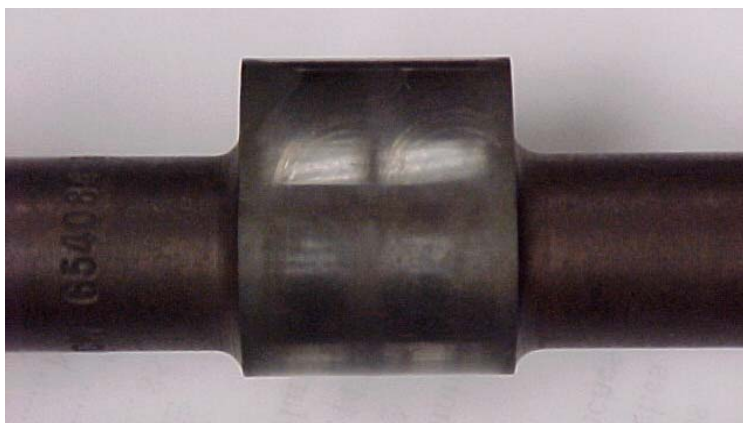
FIGURE 11 TYPICAL CAM LOBE WEAR SIGNATURES

CAM LOBE OPENING FACE

APEX OF CAM LOBE

CAM LOBE CLOSING FACE

(2) Perform visual inspection using an inspection light. If the surface is smooth and shiny with only small areas of rough appearance, no further action is required.

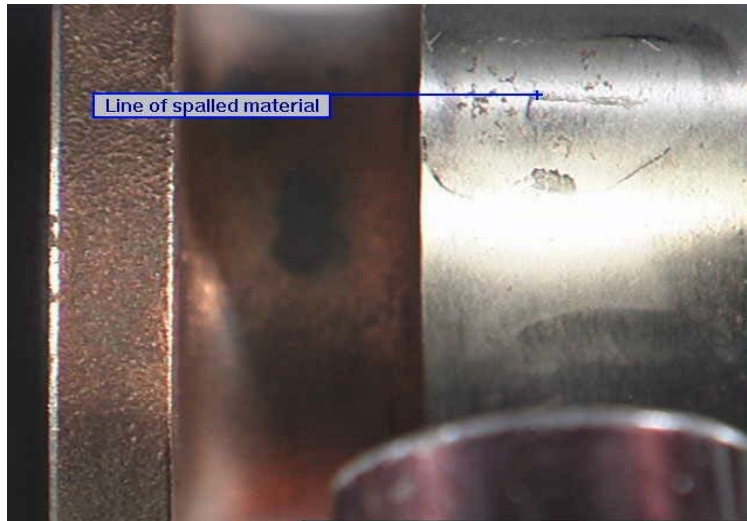
In some cases, significant spalling may result in some damage to the cam lobe apex. This level of damage is rare, but will manifest itself as surface cracks on the nose with some depth. Note that appearance of the cam lobe apex may vary normally, and only if such cracks are present should the camshaft be considered a candidate for replacement. Corrosion (rust) will also cause cam lobe distress. See the INSPECTION SECTION for specifics.

SPALLED CAM LOBE

FIGURE 12 SUSPECT CAM LOBE APEX SIGNATURES

Using a sharp pick, move the point over the nose. If a crack like feature has any depth, the pick will catch in the groove or pits. If no positive indication of a crack is felt, no further action is required. If an indentation is present, the cam must be examined by a TCM service representative to determine the next steps.

NOTE
CONTACT TCM SERVICE DEPARTMENT TO ARRANGE EXAMINATION OF THE
SUSPECTED AREA BY A TCM SERVICE REPRESENTATIVE.

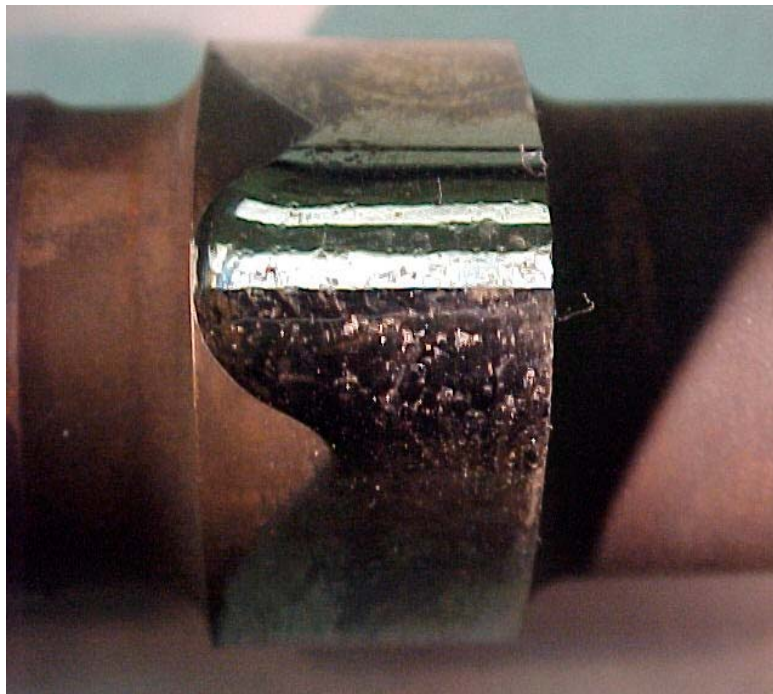
CORROSION PITTED CAM LOBE

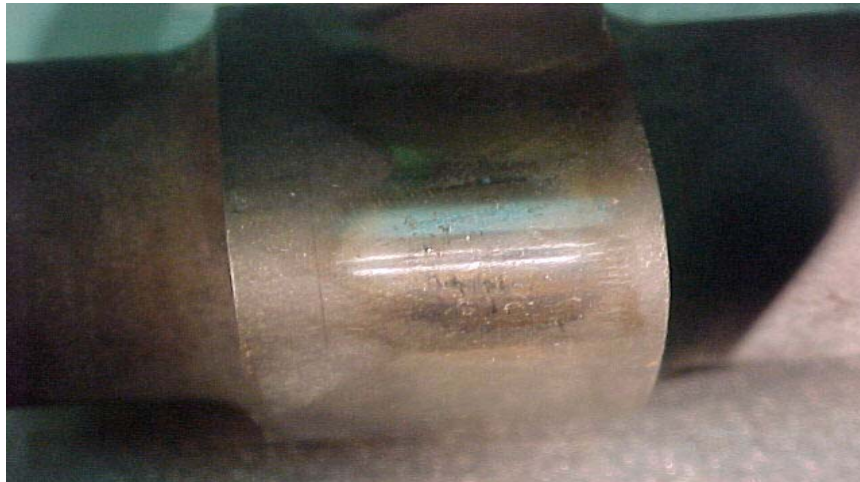
FIGURE 13 CAM LOBE APEX MINOR DISTRESS

For minor distress, the camshaft may be continued in service and re-examined upon the accumulation of 100 hours operation or 12 months, whichever occurs first. If the TCM representative determines the camshaft should be replaced, the engine should be removed for repair. Note that cylinder removal to gain better access may be required to make the final determination.
