NEW AD ON ELEVATOR TRIM HARDWARE AFFECTS ALL TWIN CESSNAS

by Tony Saxton, Director of Tech Support

On February 29th of this year, Cessna issued MEB-27-02 which mandates the replacement of elevator trim push-pull tube hardware. My initial response was "Cessna, what took you so long"?

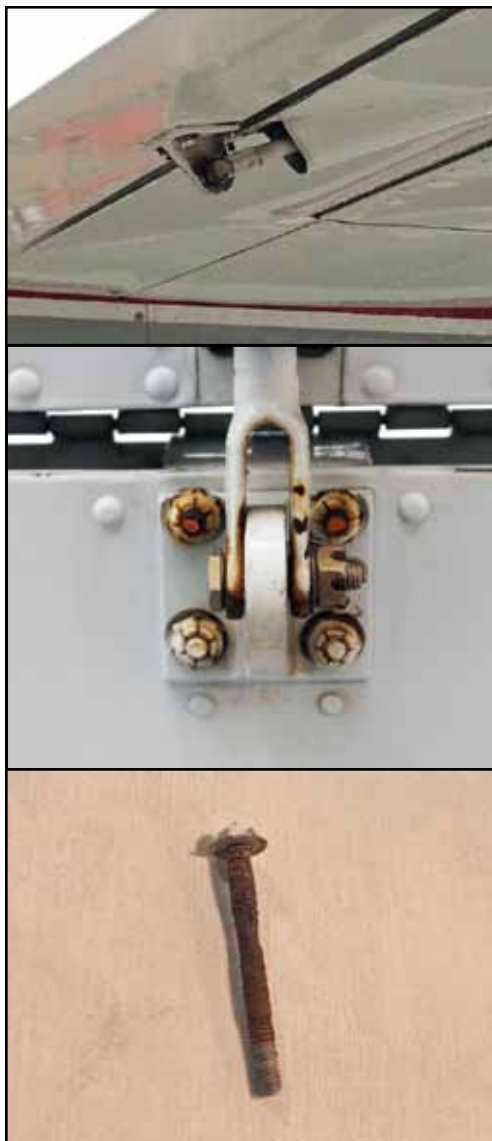
Elevator trim hardware has been a Twin Cessna trouble spot since the beginning. The attach bolts are often the wrong hardware and in poor condition.

airplane lost the elevator trim attach bolt, and the resultant tab flutter jammed the tab full up, with a severe nose pitch down. This high G overspeed caused parts of the tail to fail and the 340 entered an inverted flat spin to the ground that killed Don Evans, the test pilot.

Cessna immediately changed the production specifications of the aircraft to include the hardware called out in current MEB-27-02 and also released a service bulletin, ME73-15 to replace the hardware in previously produced 300-400 series aircraft. Again, in 1977, Cessna released service Bulletin ME77-34 for all models 310-421 Trim Control System Inspection.

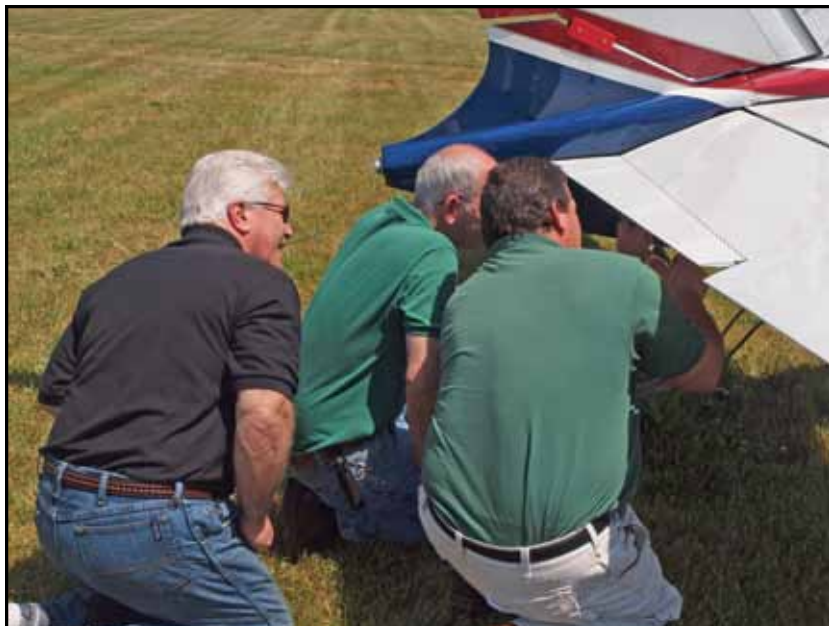
Tony (center) demonstrating how to inspect elevator trim tab connection hardware at a Systems Seminar. It's not uncommon to find improper parts and severe corrosion. This AD will further address these issues.

Owners worry about engines, radios, landing gear etc., but as I say about these lowly bolts during the seminars, "This right here will kill you!" In addition to hardware replacement, we preach at the seminars to know where and what these attach bolts look like and preflight inspect them, especially following any type of maintenance event.
