Service Bulletin

June 16, 1995

MEB95-9

CABIN HEATER FUEL LINE INSPECTION/REPLACEMENT

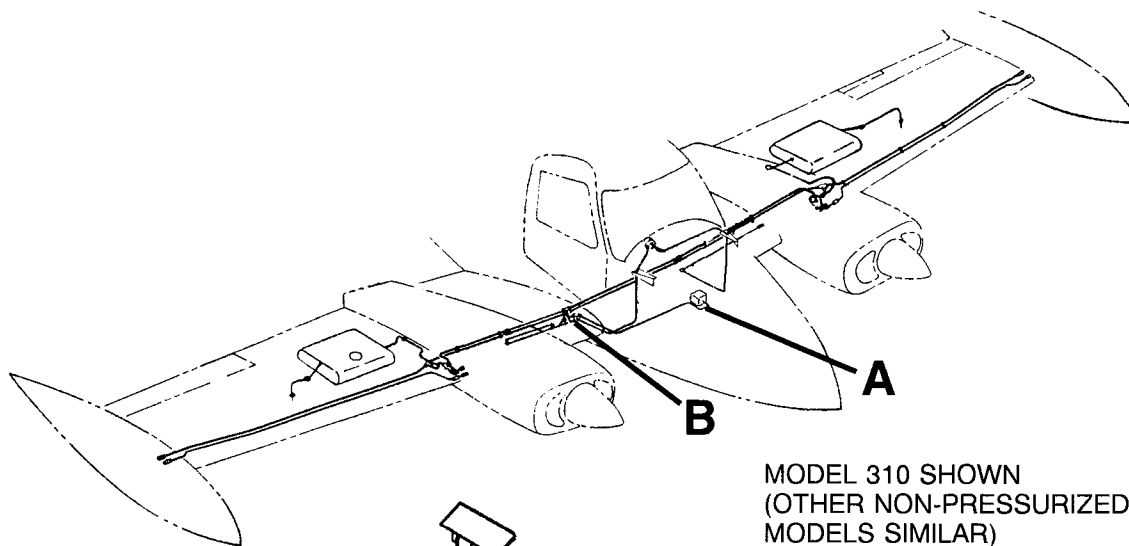
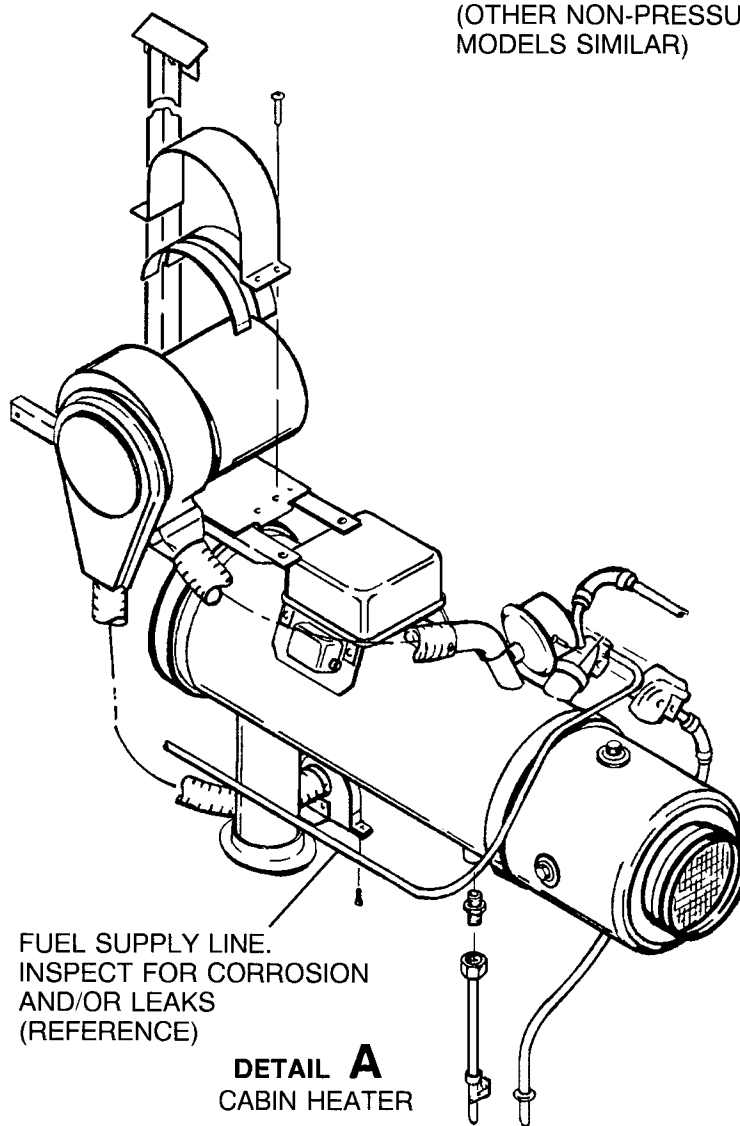
Figure 1. Cabin Heater Fuel Supply Line and Components (Sheet 1 of 2)

4. Inspect the fuel line for corrosion and/or leaks. (Refer to the Service Manual.)

FUEL SUPPLY LINE.
INSPECT FOR CORROSION
AND/OR LEAKS
(REFERENCE)

5. Mix Metal Glo #6 with equal amounts of water per manufacturers instructions.
6. Remove light corrosion pits less than 0.005 inch deep or surface discoloration as follows:

- F. Apply pretreatment (Iridite 14-2 or Alodine 1200S), per the manufacturers' instructions, to aluminum line where corrosion was removed.
7. Remove moderate corrosion pits greater than 0.006 inch deep but less than 0.016 inch deep as follows:

8. If leaks are detected that are a result of material corrosion, or if corrosion in excess of 1/2 the wall thickness, (0.017 inch deep), is found, the line assembly shall be replaced. (Refer to the Service Manual, Heating System - Maintenance Practices.)

- A. Replace damaged or corroded line with a current new aluminum line assembly. (Refer to applicable parts catalog for part number of existing line assembly.), or using the S617780, or S617847 321 stainless steel tube (which ever is applicable), AN818-4K nuts, and MS20819-4K sleeves, fabricate a new line to match the existing cabin heater fuel supply line.

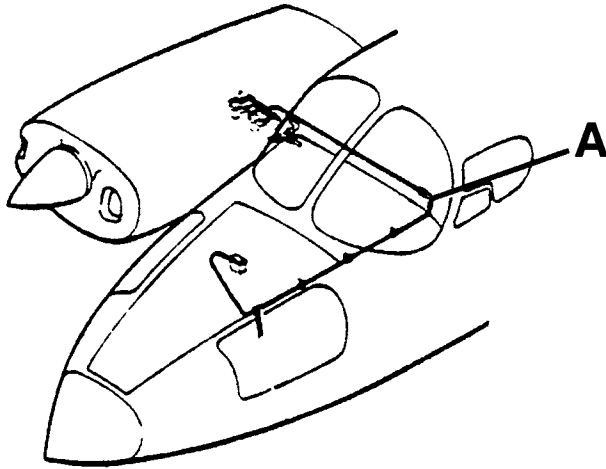
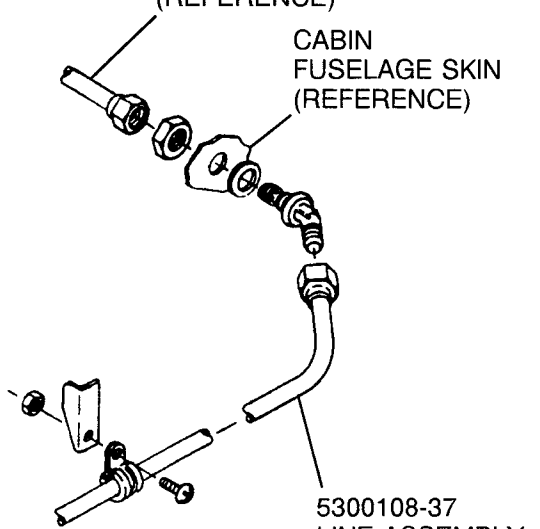
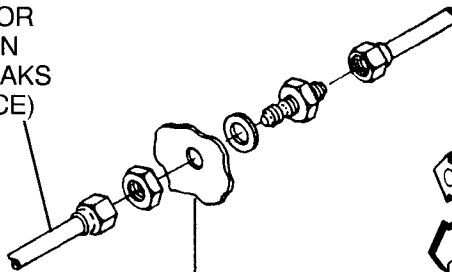
Figure 2. Cabin Heater Fuel Supply Line and Components (Sheet 1)

NOTE: The cabin heater fuel supply line in the cabin and nose baggage are the areas of concern in pressurized airplanes.

5300108-37
LINE ASSEMBLY
WING ROOT
TO STA 100.00
BULKHEAD.
INSPECT FOR
CORROSION
AND/OR LEAKS
(REFERENCE)

FUEL LINE TO
CABIN HEATER.
INSPECT FOR
CORROSION
AND/OR LEAKS
(REFERENCE)
