# ALERT SERVICE BULLETIN

ASB273B

A-20028 IDLER GOVERNOR GEAR BEARING INSPECTION INSTRUCTIONS

FAA-Approved Propeller Repair Stations, Aircraft Manufacturers, and Owners and Operators

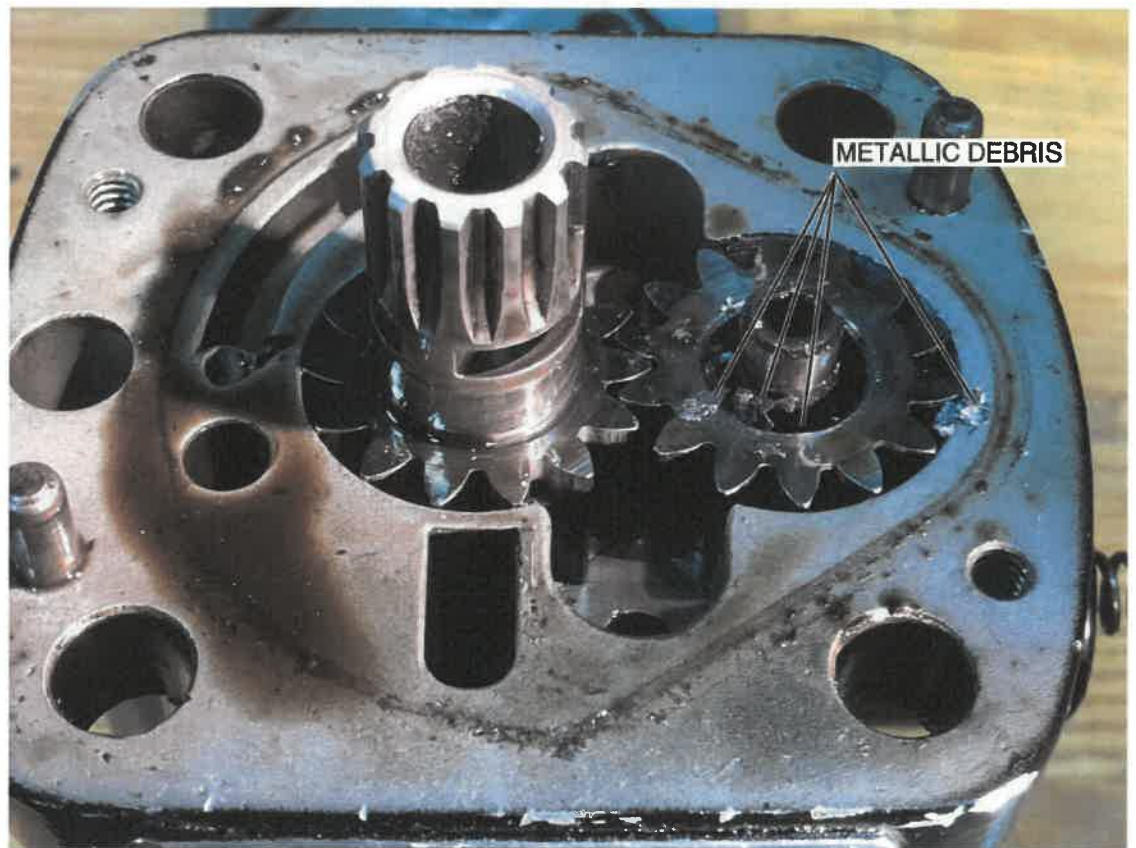
Figure 1. Metallic Debris Example (Sheet 1)

1. DO THE A-20028 IDLER GOVERNOR GEAR BEARING INSPECTION
  - A. Governor Evaluation, do the following:
    - (1) Remove the affected governor from the engine in accordance with the aircraft manufacturer or applicable STC holder's instructions.
    - (2) Remove the C-20943 cover-pump housing from the governor assembly. Examine the inside of the housing and the base of the exposed governor (Refer to Figure 1). Note and photo document any signs of metallic debris.

**D. If Metallic Debris WAS Observed/Noted, refer to the McCauley Governor Manual 780401 and do the following:**

- (1) Remove and retain the A-20107 idler gear assembly.
- (2) Overhaul the governor and complete associated actions as indicated in McCauley SB215C
