**FAA
Aviation Safety**

SPECIAL AIRWORTHINESS INFORMATION BULLETIN

SUBJ: Exhaust Turbocharger; V-band Couplings Used in Exhaust Systems on Turbocharged Reciprocating Engine Powered Aircraft **SAIB:** CE-18-07
Date: December 14, 2017

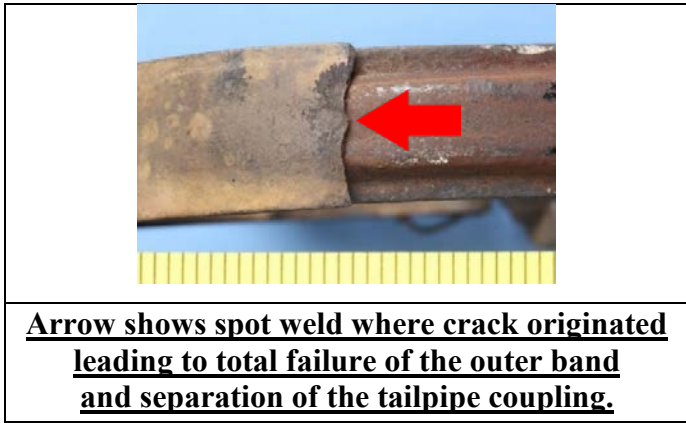
Reference: turbocharger to tailpipe interface

The FAA is aware of three recent accidents/incidents, involving cracked and/or separated multi-segment, spot welded, v-band couplings, which resulted in four fatalities. The failed and cracked v-band couplings pictured below are from the accident/incidents noted above.

- cracks in the outer flat band at or near a spot weld;
- signs of over opening of the coupling or excessive twisting;
- misuse of the coupling(s) to bring exhaust system components together and into alignment;
- over-torquing, outer band material stretching and deformity; and
- exhaust gas leakage, overheating, heavy accumulation of oxides, and corrosion.

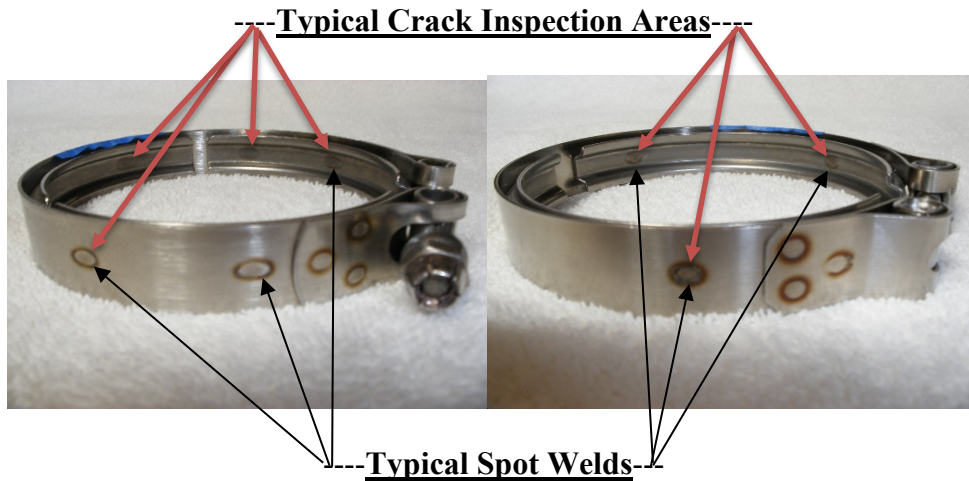
- c. Cracks in the coupling v-retainer segment interior or exterior surface, e.g. at bend radii.
- d. Looseness, separation of the outer band to v-retainer segment(s) at any spot-weld.
- e. Gaps between the v-retainer segments and the outer band at or between spot-welds.
- f. Corrosion that is not easily removed from any component of the coupling.
- g. Deformity, including but not limited to, out of round, twisted, re-formed by any method.
- h. Physical damage, including but not limited to, cracks, gouges, tears, bulges, fractures.
- i. Repairs or any indications of past repairs, as no repair process is known to be effective.

If any of the above conditions are found, the v-band coupling is considered unairworthy and should be removed and replaced before further flight with a new, zero time in service (TIS), FAA-approved coupling according to the instructions and procedures found in the airframe or engine ICA's, as applicable. All v-band couplings removed from service should be permanently destroyed and not used on any other aircraft or aircraft application.
