SERVICE BULLETIN

SB07-1

**SUBJECT: CONNECTING ROD PISTON PIN BUSHING
INSPECTION**

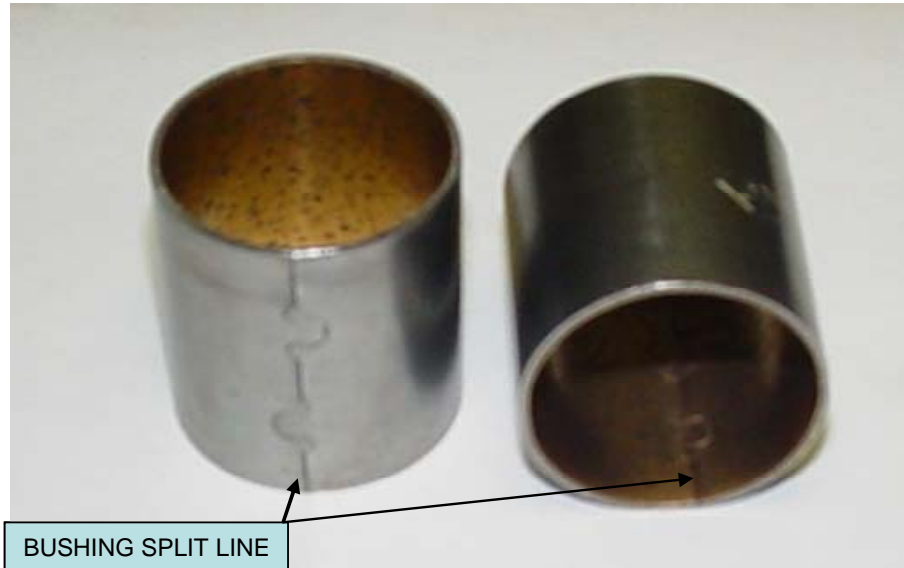
FIGURE 1
Typical New Piston Pin Bushing

Teledyne Continental Motors (TCM) has received reports from the field of piston pin bushing material being found in the sump or the oil filter. Piston pin bushings are manufactured from steel-backed bronze and are curved on a radius of approximately 0.62". (Reference Figure 1)

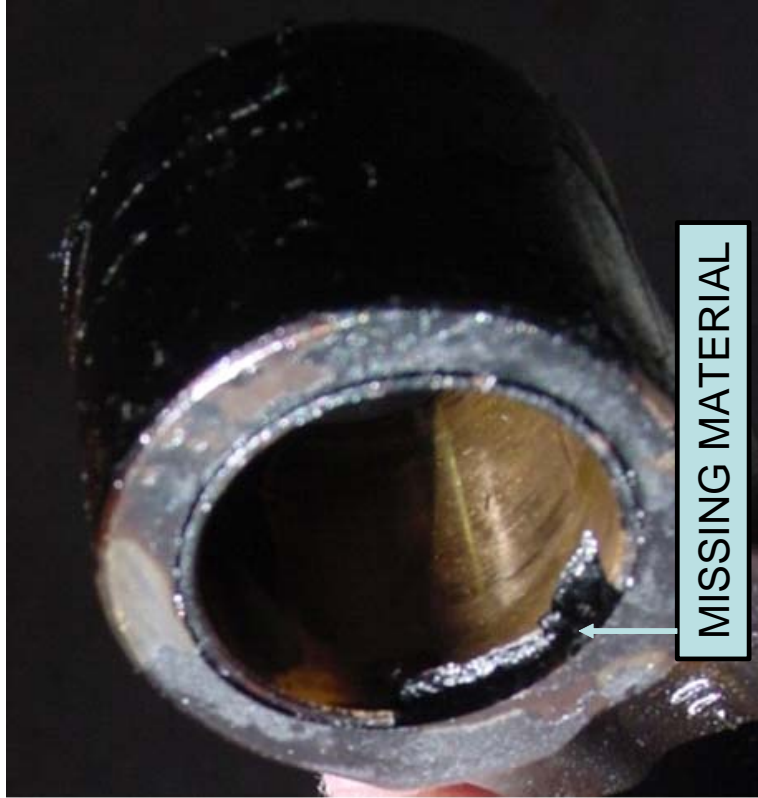
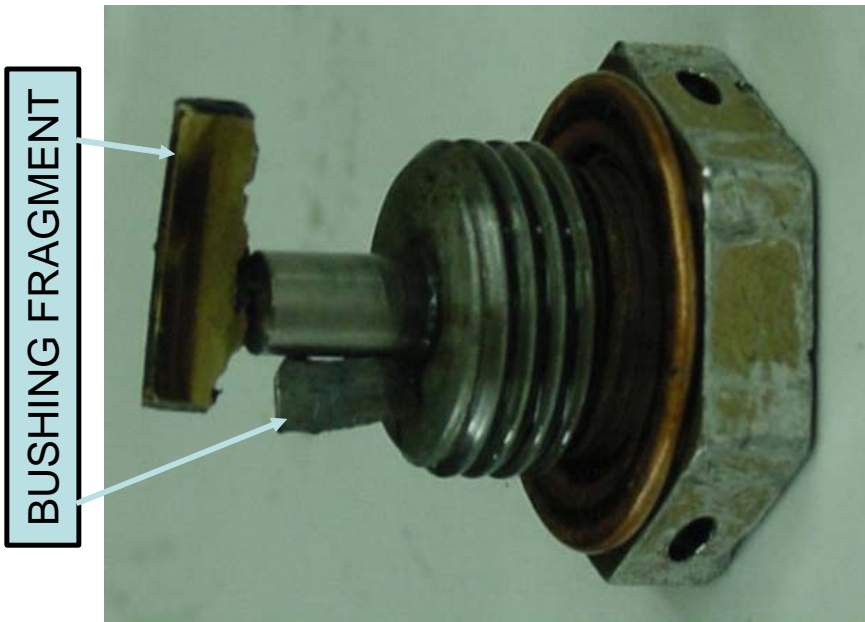
FIGURE 2
TYPICAL INDICATIONS

If piston pin bushing material is recovered from an engine, (Reference Figure 2) all of the cylinders, pistons, and piston pins must be removed to allow access for inspection of the connecting rods piston pin bushings. **In addition, the piston pin bushing must be inspected for condition each time a cylinder is removed for any reason.**

- 2) The piston pin bushing split line (Reference Figure 1) must be positioned within the arc indicated in Figure 3, no closer than 40° to the connecting rod centerline.
- 3) The piston pin bushing must be visually inspected for any signs of cracks emanating from the piston pin bushing split. (Reference Figure 2)
- 4) Inspect the piston pin bushing for wear in accordance with the latest revision of bulletin SB00-3.
- 5) Any piston pin bushing that does not meet the installation criteria in item (2) above or is found cracked per the inspection in item (3) above must be replaced.
- 6) Any piston pin bushing that exhibits excessive wear when inspected IAW the latest revision of SB00-3 must be replaced before further service.
