SERVICE INFORMATION DIRECTIVE
Compliance Will Enhance Safety, Maintenance or Economy of Operation

SID 05-1

SUBJECT: THIS SERVICE INFORMATION DIRECTIVE (SID) SUMMARIZES INFORMATION PERTINENT TO THE DESIGN, OPERATION, MAINTENANCE AND WARRANTY FOR TCM CAMSHAFTS AND HYDRAULIC LIFTERS

MODELS AFFECTED: All TCM engine models

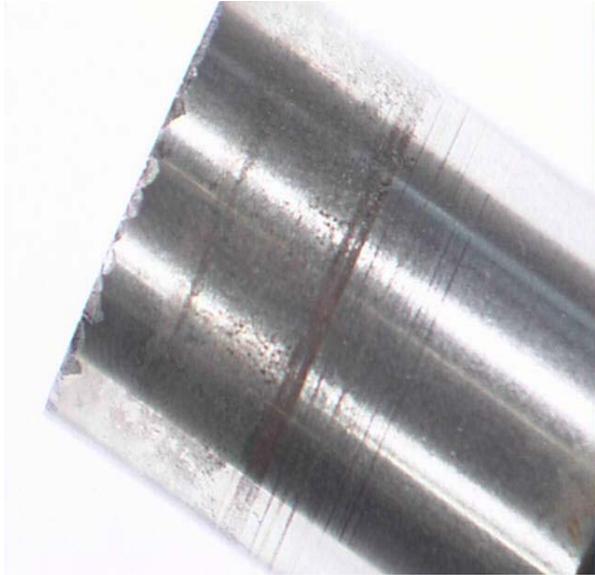
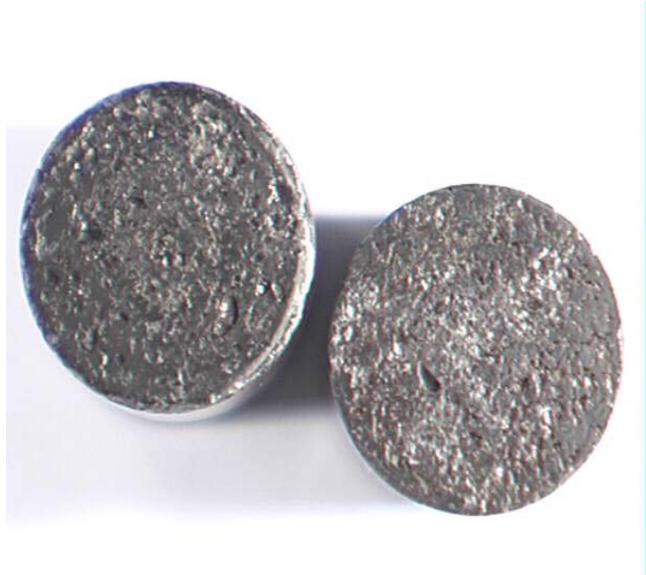
In very rare cases, the lifter deterioration will cause significant wear to the cam lobe. In such cases, the lift of the valve may be reduced. Initially, the effect on performance would be negligible, but may eventually lead to reduction of power of the cylinder effected. Valve lift is in the order of one-half inch so the wear would have to be extreme to noticeably effect cylinder performance. Note that the hydraulic lifter has a limited range of hydraulic adjustment and would run out of travel before extreme wear occurred. This could result in an audible tapping noise from the engine.

CORROSION ETCHING ON BODY

FULL FACE SPALLING

FIGURE 7 LIFTER CORROSION AND SIGNIFICANT SPALLING

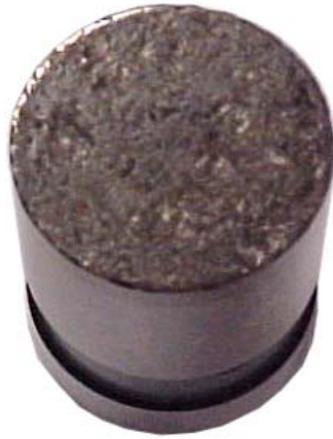
FIGURE 9 REPLACEMENT SIGNATURES, SPALLED LIFTER

Replace lifters with severe face or lifter body wear signatures or spalling that exceeds 10% of the surface area. Lifters associated with noise indicating excessive valve lash should also be replaced regardless of face condition.

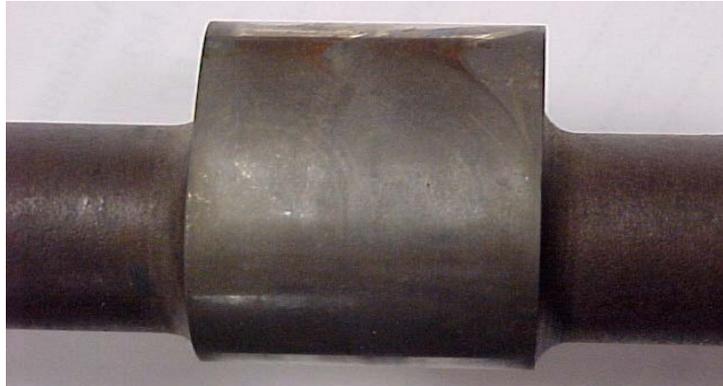
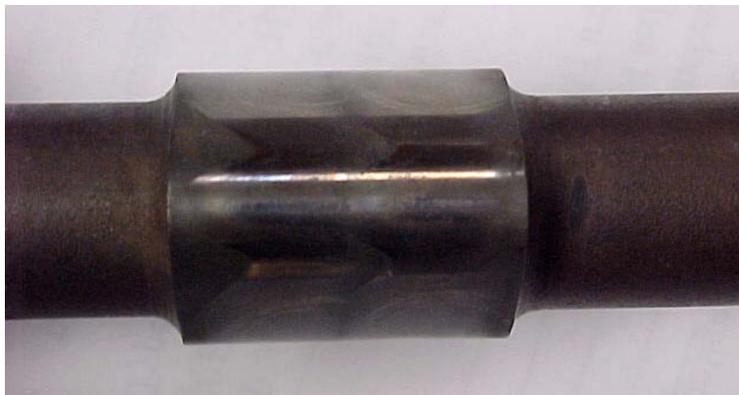
CAM LOBE OPENING FACE

APEX OF CAM LOBE

CAM LOBE CLOSING FACE

FIGURE 11 TYPICAL CAM LOBE WEAR SIGNATURES

(2) Perform visual inspection using an inspection light. If the surface is smooth and shiny with only small areas of rough appearance, no further action is required.

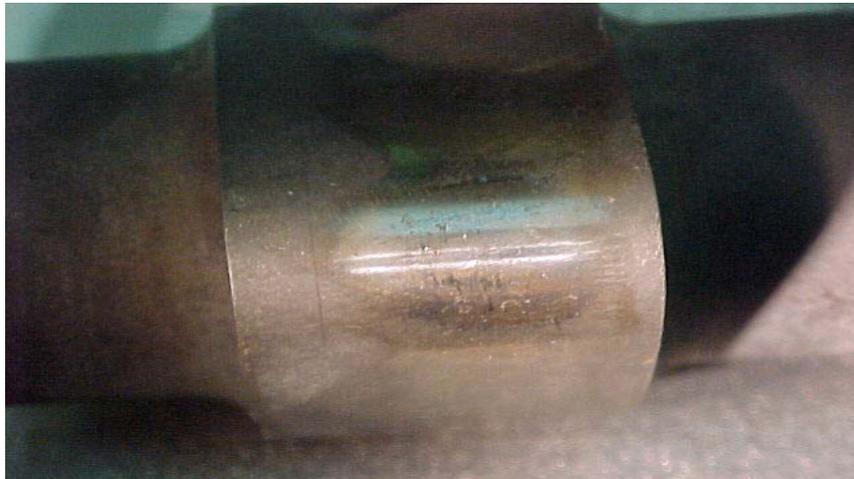
FIGURE 13 CAM LOBE APEX MINOR DISTRESS

For minor distress, the camshaft may be continued in service and re-examined upon the accumulation of 100 hours operation or 12 months, whichever occurs first. If the TCM representative determines the camshaft should be replaced, the engine should be removed for repair. Note that cylinder removal to gain better access may be required to make the final determination.
